8. Small Landslides

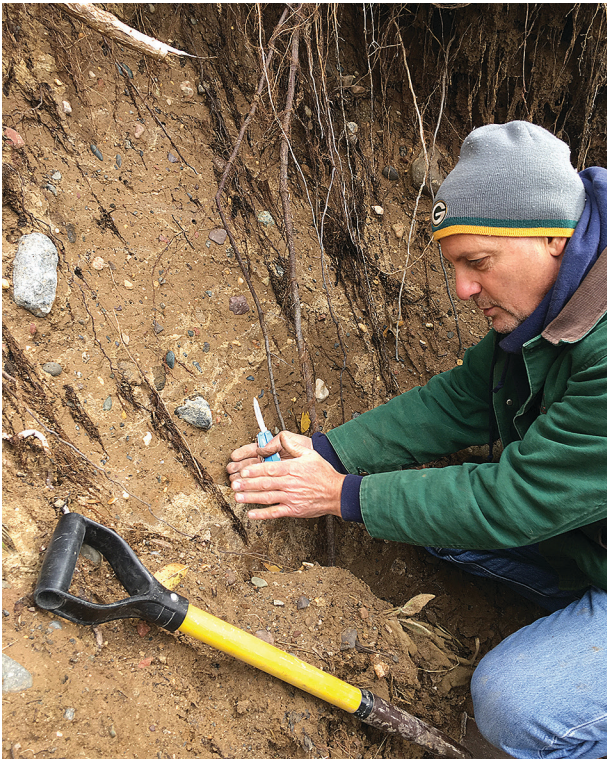
Figure 8.1— Soil Investigation

Twin Cities Formation parent material with sand seams exposed in a shallow slide on Interlachen Golf Course. The dense glacial sediment was covered with loose sediment of similar texture and composition. A horizon where density increased was the base for the shallow slide according to Dr. John Beck, NRCS.

The main commonality in these sites in the interior of the county was a sharp increase in density at shallow depth, typically within a meter or two of the surface. This was determined by ease of coring and by inspection with a shovel (Figure 8.1). A decrease in density of the surface layer could result from frost heave, bioturbation or human disturbance. It may also result from the original processes that deposited the glacial sediment with normally consolidated supraglacial sediment overlying over-consolidated subglacial sediment. In the case of the site in Theodore Wirth Park, some degree of compaction appeared to have resulted from trail use by people on foot and bicycle. More loosely consolidated sediment appeared to have been spread in attempts to improve the site through re-grading and planting (Figure 8.1).

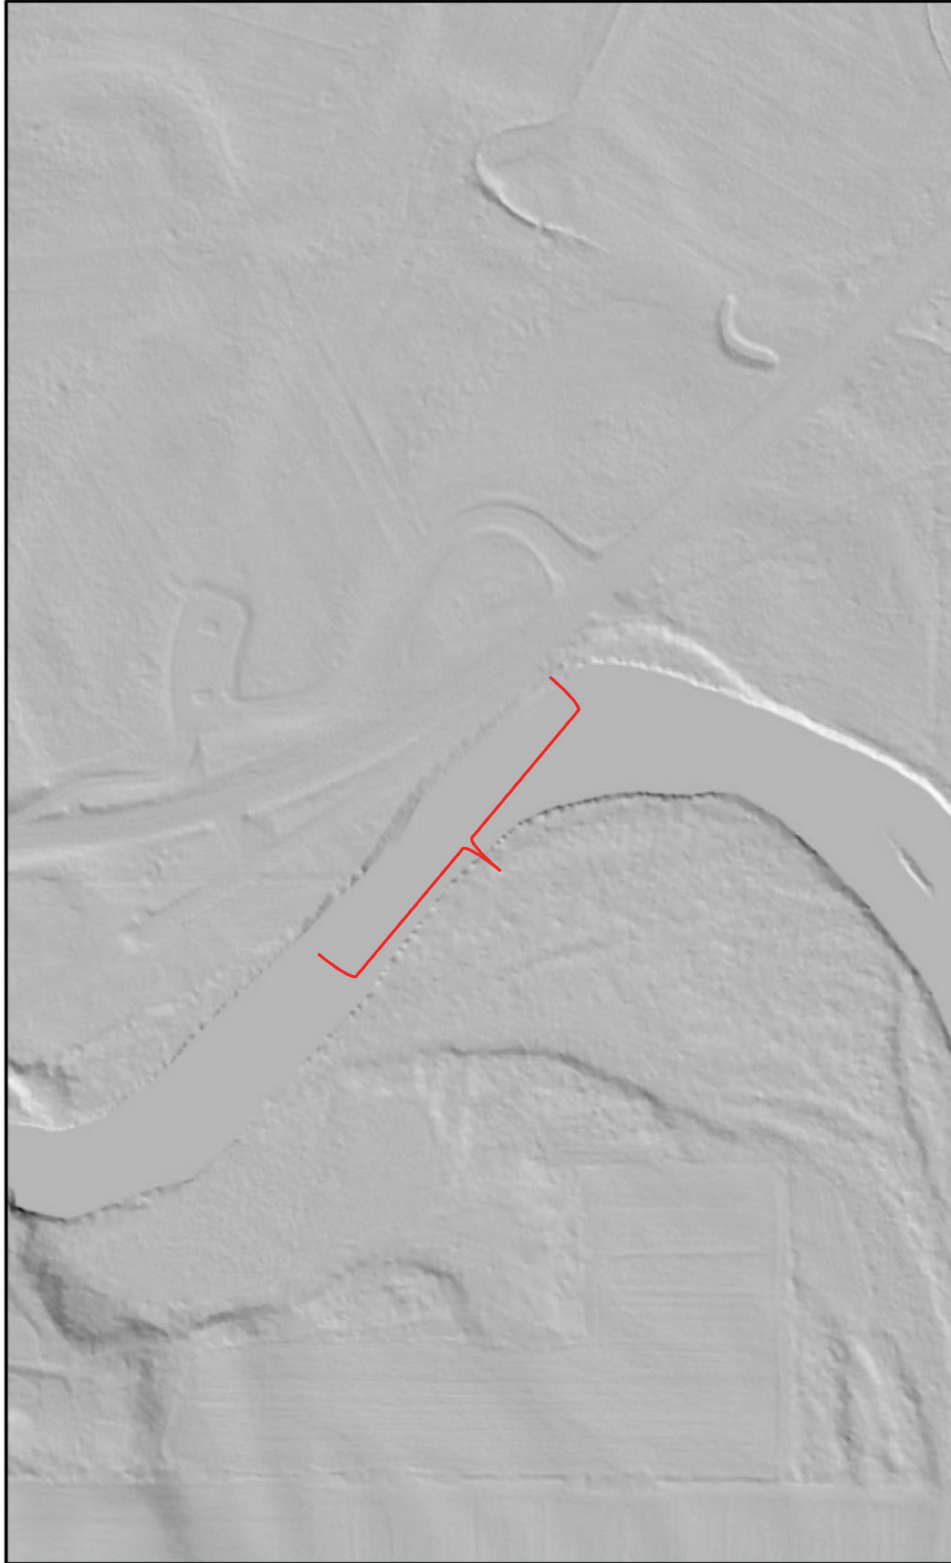
Figure 8.2 — Crow River Near Sportsmen’s Club

One example of this is near the Crow River Sportsmen’s Club, west of County Road 22. The red bracket in the figure shows where the slope has been protected along the outer meander bend. However, river widening and infrastructure effects are creating similar failures on inner meander bends and near bridges.

Along the Crow River where the slopes are formed in sandy parent material, the stability issue results from oversteepening of slopes composed of sediment with low cohesion. An increase in steepness will result in failure in sediment that is not cohesive. This happens naturally as a meander migrates into a stream's outer, downstream bank; and it happens somewhat unnaturally where rivers are widening because of alterations to hydrologic conditions upstream and where they are constrained by infrastructure (Figure 8.2).
